TEST REPORT NO: FITI/LAB/22/02/27

Test Report For Laboratory Performance Testing of Dry Cladding System.

**: Project :
SFS1**

**: Testing Laboratory :
FAÇADE INDIA TESTING INC
H-23, Additional MIDC, Kudavali Village
Murbad, Maharashtra State 421401.**

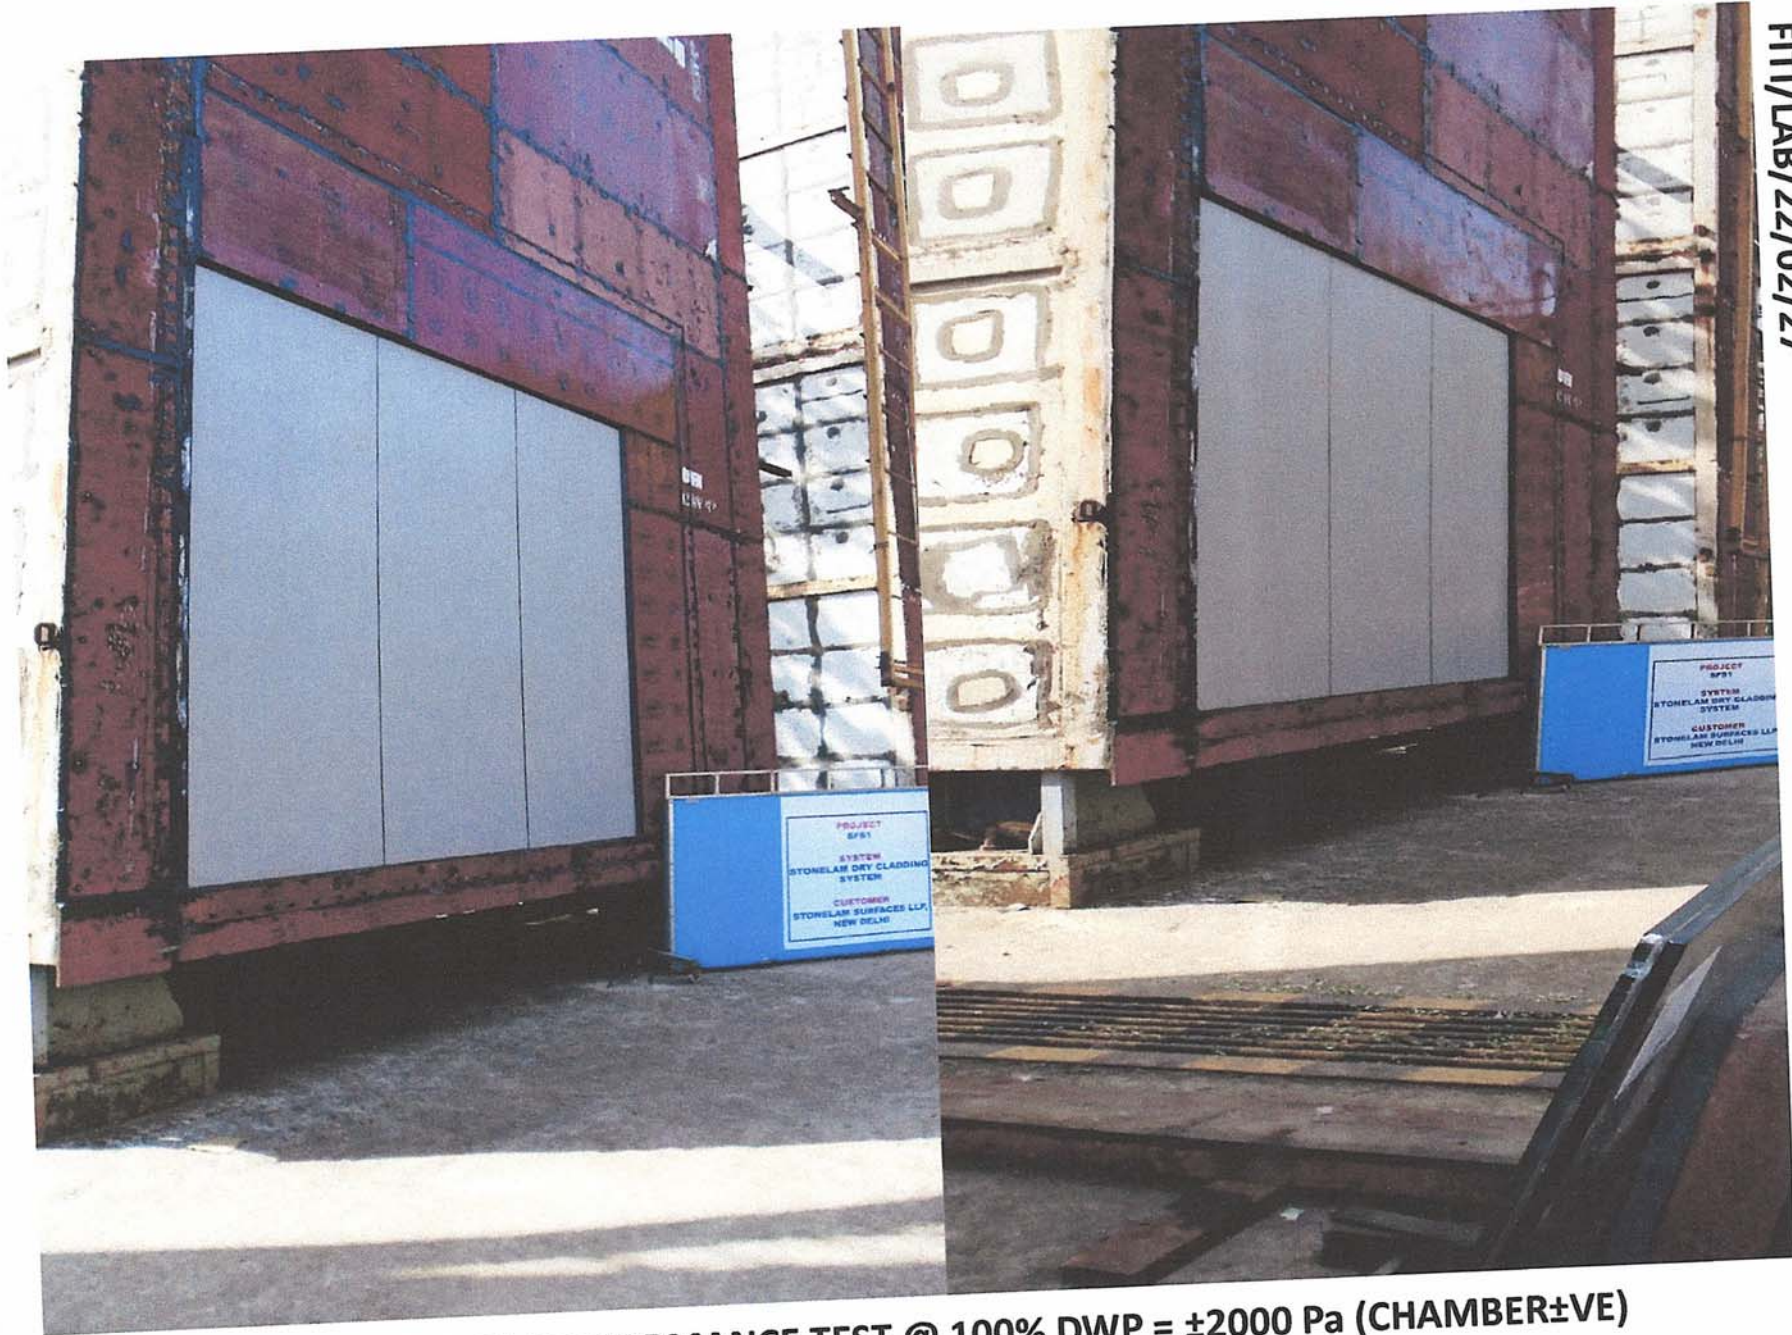
STRUCTURAL PERFORMANCE TEST @ 100% DWP = ± 2000 Pa (CHAMBER \pm VE)

Structural Performance Test at Design Wind Pressure Chamber Negative was performed on 3rd february 2022 after completion of Pre Load Test. The structural performance test was conducted as described in the method statement. The deflection transducers were placed as shown in the drawing diagram and initial values were set zero. The pressure was decreased upto -1000 Pa (50% of design wind pressure) and held for 10 seconds and the deflection values were recorded before bringing back to the zero. Residual deflection values were set zero. After 3 min, chamber pressure decreased upto -2000 Pa (100% of design wind pressure) in chamber and held for 10 seconds and the deflection values were recorded before bringing back to the zero. The permissible deflection Vs actual deflections were compared. The actual deflections were found within permissible limit. Residual deflections were observed zero. The test was recorded as Compliance. The test record sheets with deflection values are included in the Annexure. It was decided to proceed with Structural Performance Test at Design Wind Pressure Chamber Positive.

Structural Performance Test at Design Wind Pressure Chamber Positive was performed on 3rd February 2022 immediately after completion of Structural Performance Test at Design Wind Pressure Chamber Negative. The structural performance test was conducted as described in the method statement. The deflection transducers were placed as shown in the drawing diagram and initial values were set zero. The pressure was increased up to +1000 Pa (50% of design wind pressure) and held for 10 seconds and the deflection values were recorded before bringing back to the zero. Residual deflection values were set zero. After 3 min, chamber pressure increased up to +2000 Pa (100% of design wind pressure) in chamber and held for 10 seconds and the deflection values were recorded before bringing back to the zero. The permissible deflection Vs actual deflections were compared. The actual deflections were found within permissible limit. Residual deflections were observed zero. The test was recorded as Compliance. The test record sheets with deflection values are included in the Annexure. It was decided to proceed with Structural Performance Test @ 150% of DWP.

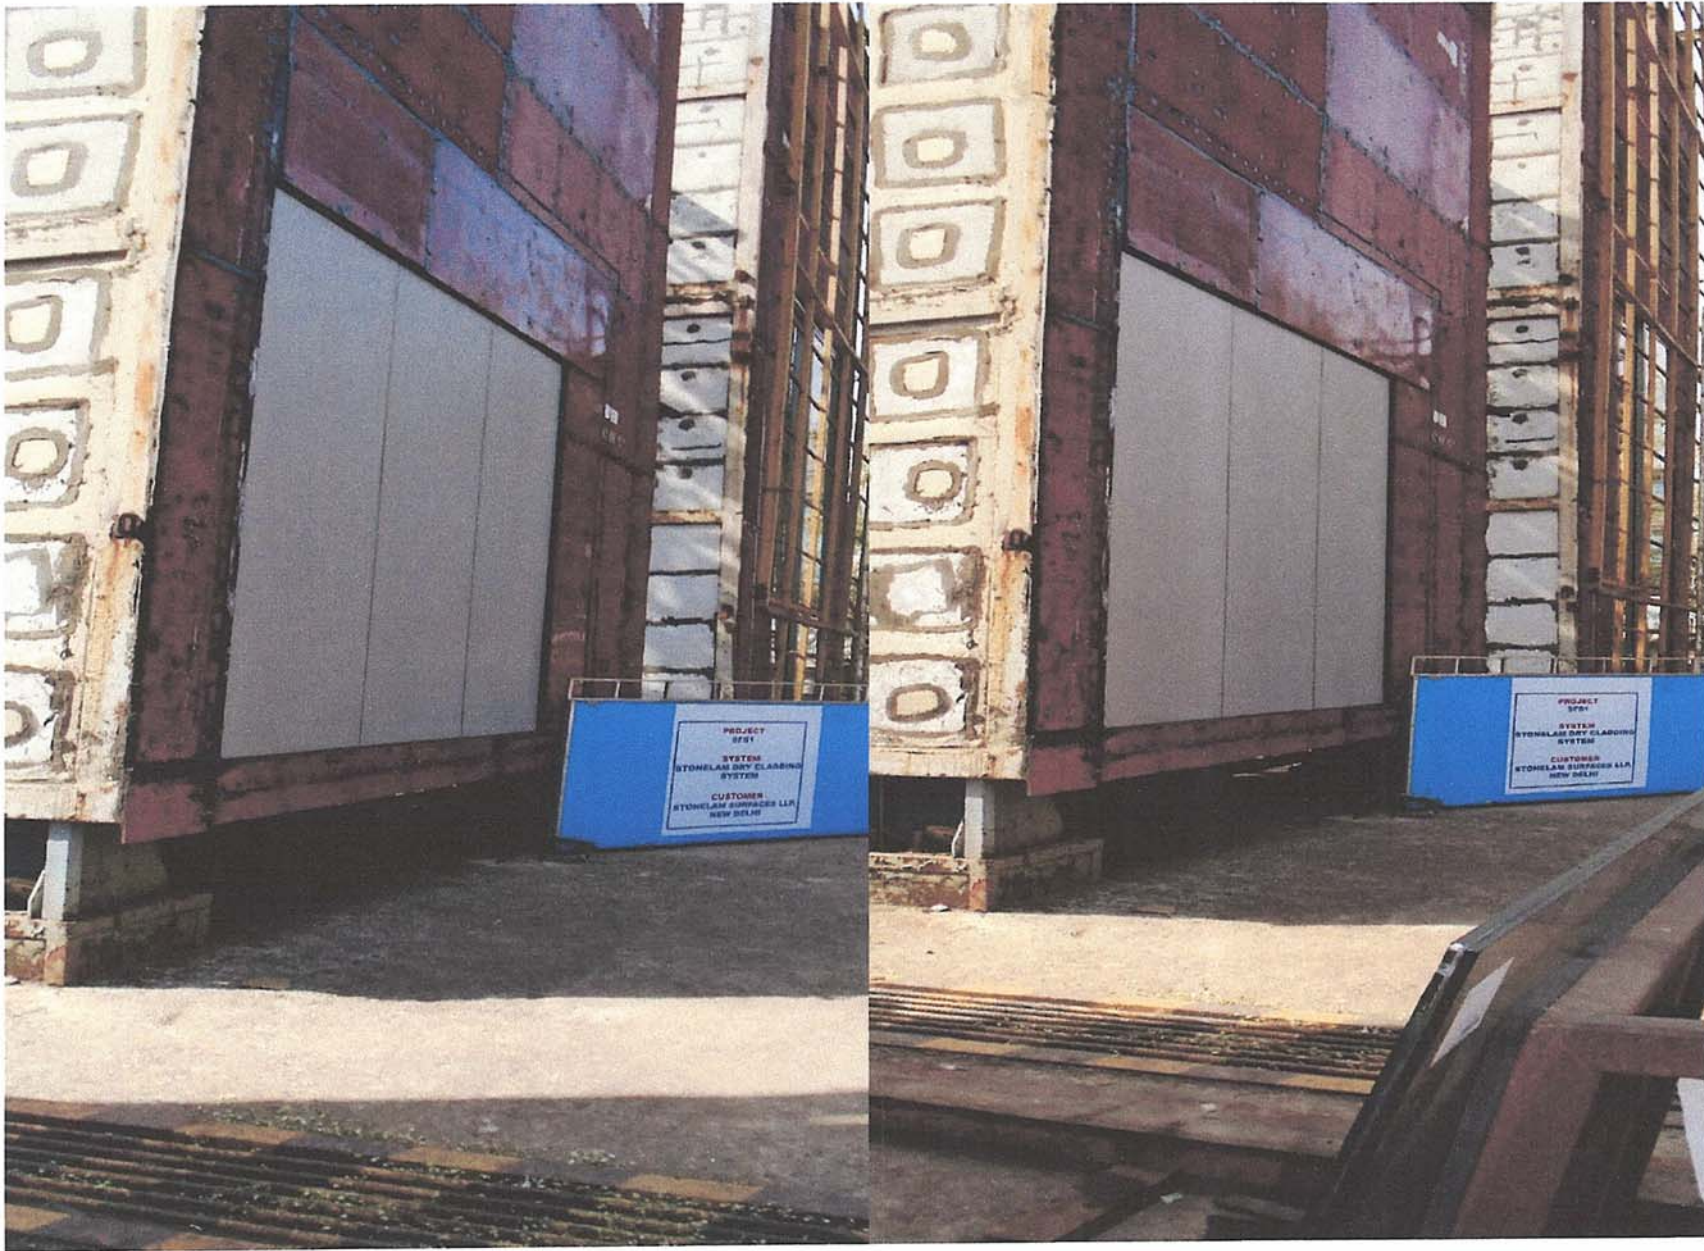
STRUCTURAL PERFORMANCE TEST @ 150% DWP = ± 3000 Pa (CHAMBER \pm VE)

Structural Performance Test Chamber Negative at 150% Design Wind Pressure was conducted on 3rd February 2022. Prior to the test initial values of deflection transducers were set zero. The chamber pressure was decreased up to -1500 Pa (75% of DWP) and held for 10 seconds, before bringing back to zero Pascal. Subsequently, chamber pressure was decreased up to -3000 Pa (150% of DWP) and held for 10 seconds before bringing back to the zero. After waiting for five minute the residual deformation were recorded with the help of transducers. The actual deformation was compared and found within permissible limits. Also, no component failures were observed. Copy of test record sheet included in the Annexure. It was decided to proceed with Structural Performance Test Chamber Positive at 150% Design Wind Pressure.

Structural Performance Test Chamber Positive at 150% Design Wind Pressure was conducted on 3rd February 2022. Prior to the test initial values of deflection transducers were set zero. The chamber pressure was increased up to +1500 Pa (75% of DWP) and held for 10 seconds, before bringing back to zero. Subsequently, chamber pressure was increased up to +3000 Pa (150% of DWP) and held for 10 seconds before bringing back to the zero. After waiting for five minute the residual deformation were recorded with the help of transducers. The actual deformation was compared and found within permissible limits. Also, no component failures were observed. The test was recorded as Compliance. Copy of test record sheet included in the Annexure. It was decided to proceed with Concentrated Load Test at Panel Centre.

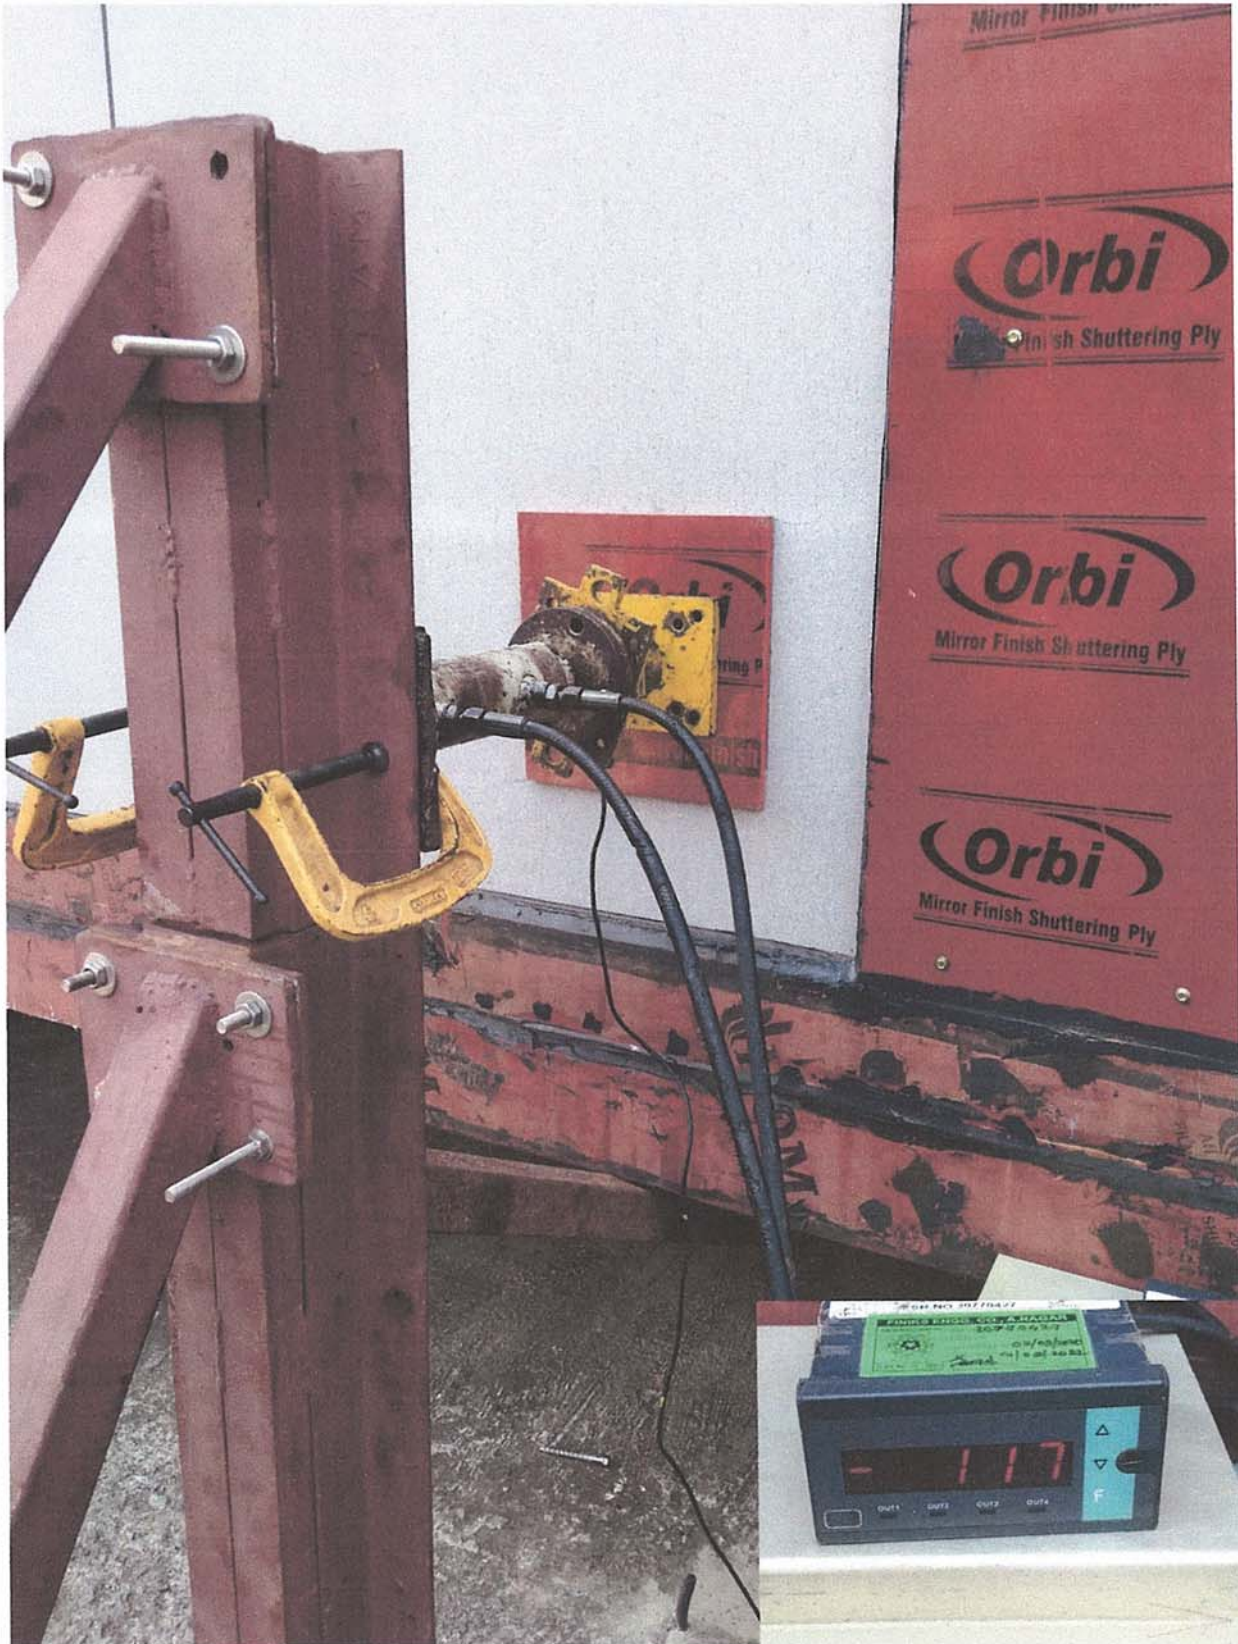
CONCENTRATED LOAD TEST @ 115 KG

150% Design Wind Pressure. The test was conducted for 115 kg concentrated load applied horizontally in push direction at one panel. The concentrated load was applied horizontally in push direction from outside at 300 mm x 300 mm surface area with the help of load cell and hydraulic jack. Maximum load was held for 60 seconds and deflection value of panel was recorded from inside. No failure of any component was observed. The test was recorded as Compliance. Copy of test record sheet included in the Annexure.

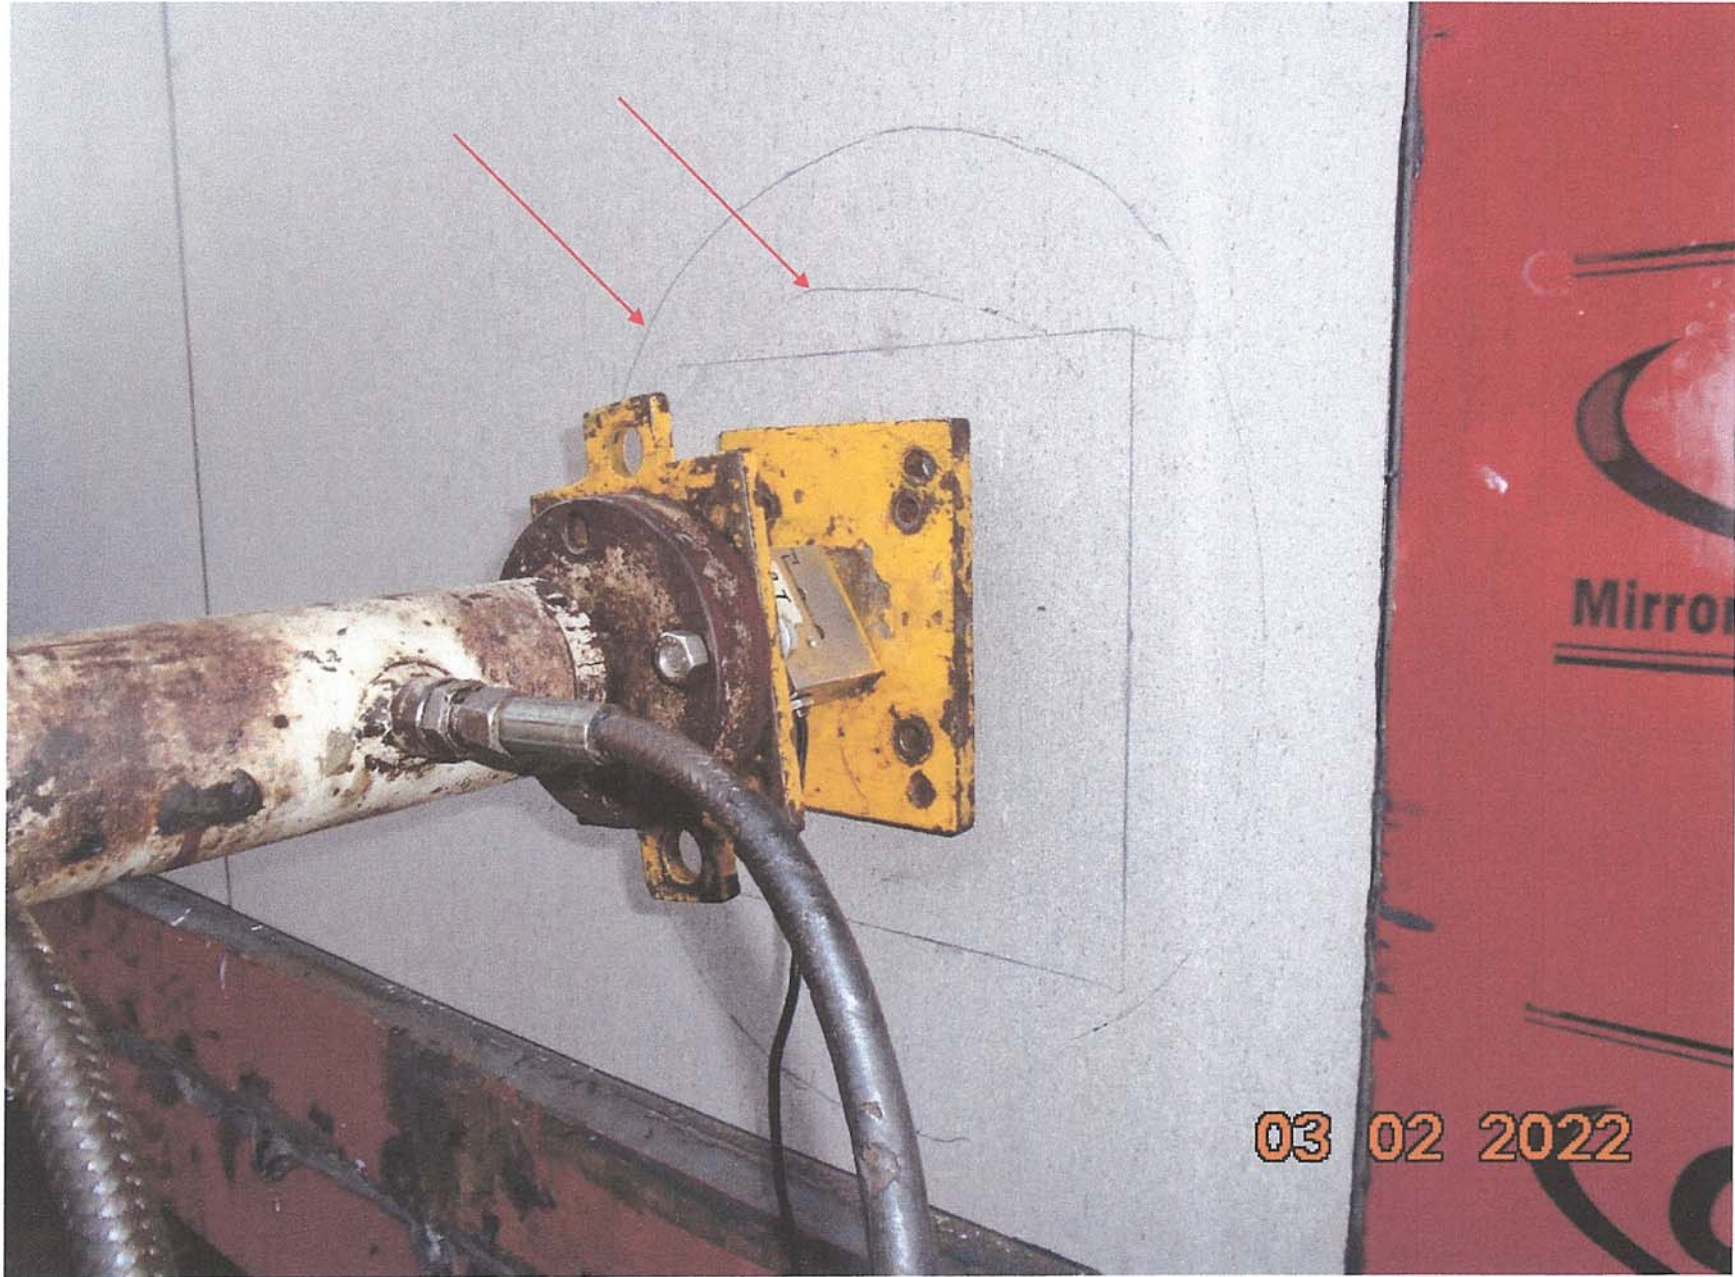
TEST TO FAILURE-CONCENTRATED LOAD TEST: 185 KG. BREAKAGE MARKS INDICATED BY ARROWS.

Concentrated Load Test at Cladding Panel Centre up to failure was performed on 3rd February 2022 immediately after completion of concentrated load test @115 kg. The test was conducted to check maximum reserved strength of sheet. The concentrated load was applied horizontally in push direction from outside at 200 mm x 100 mm surface area. The load was applied gradually with the help of hydraulic jack. At 185 kg, sheet breakage was observed from inside and outside. The test was conducted for study purpose.

OBSERVATION: A CONCENTRATED LOAD APPLIED OVER ONE LOCATION IN PUSH DIRECTION.
 LOAD ACHIEVED UP TO 185 KG BEFORE SHEET BREAKAGE. HENCE TEST CONCLUDED FOR MAXIMUM STRENGTH OF SHEET IS 185KG.

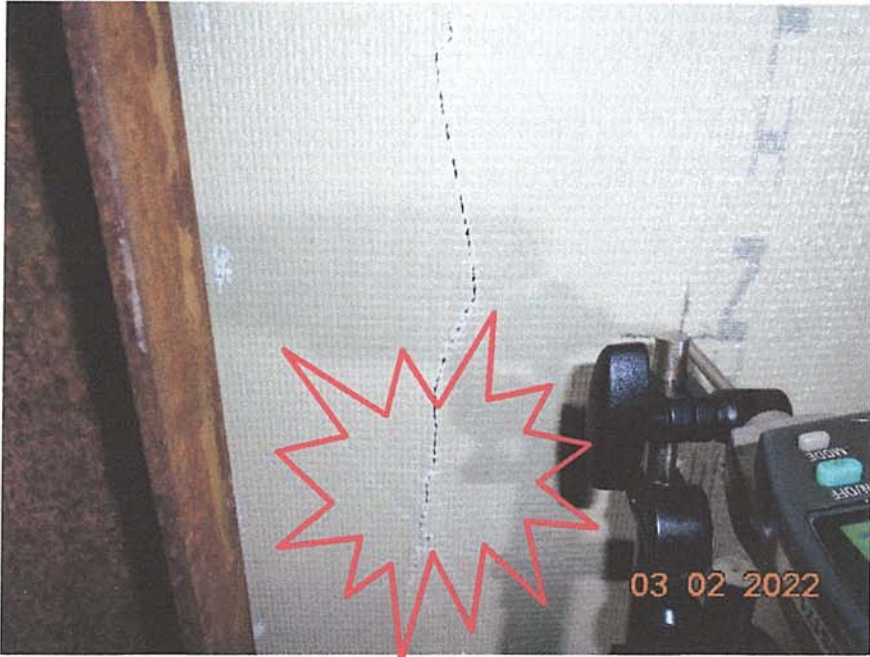
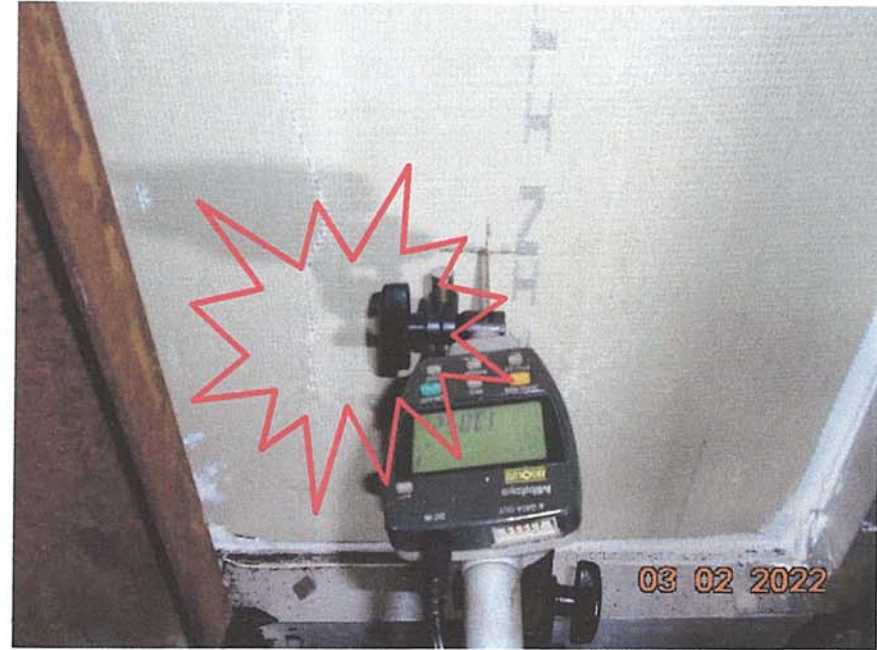
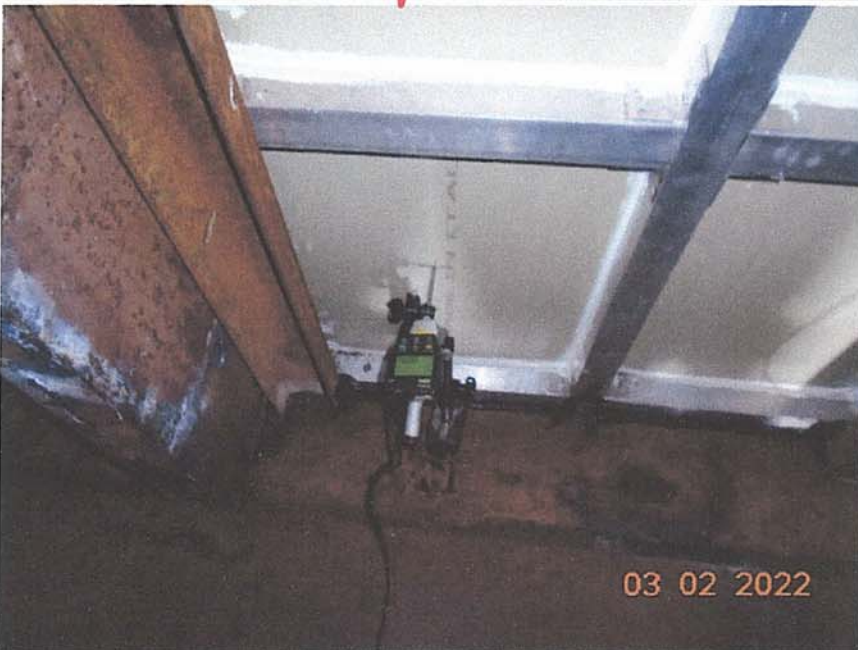
OBSERVATIONS TAKEN FROM INSIDE DURING CONCENTRATED LOAD TEST @ 115 KG AND 185 KG. NO BREKAGE WAS OBSERVED AT 115 KG. HOWEVER, CLADDING PANEL BRAEKAGE WAS OBSERVED AT 185 KG.

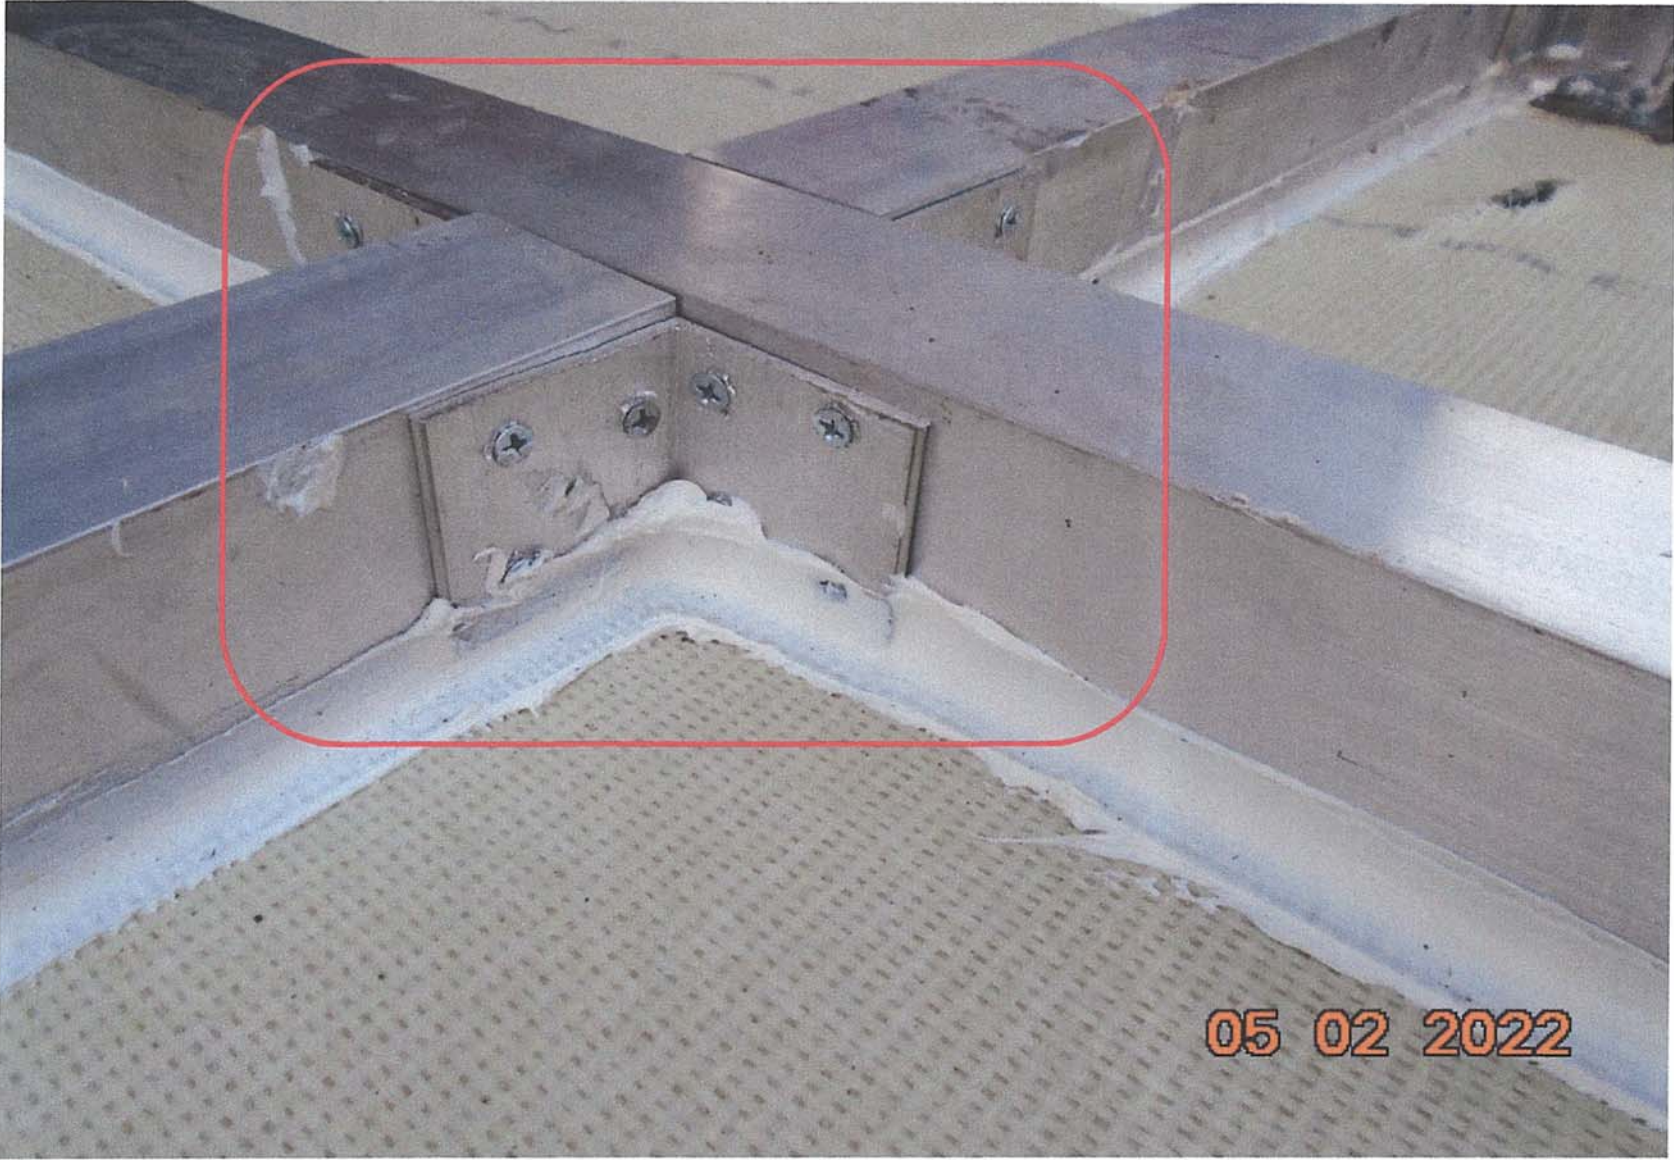
Observations: Aluminium tube of size 50X50X2 mm thk was used as mullion-transom frames. Transoms were connected with Mullion by means of using 50X50X5mm thk Aluminium L-angle and CSK screws of size 6x16. Frames and cladding panel junction was sealed with sealant. No damage observed at any joint.

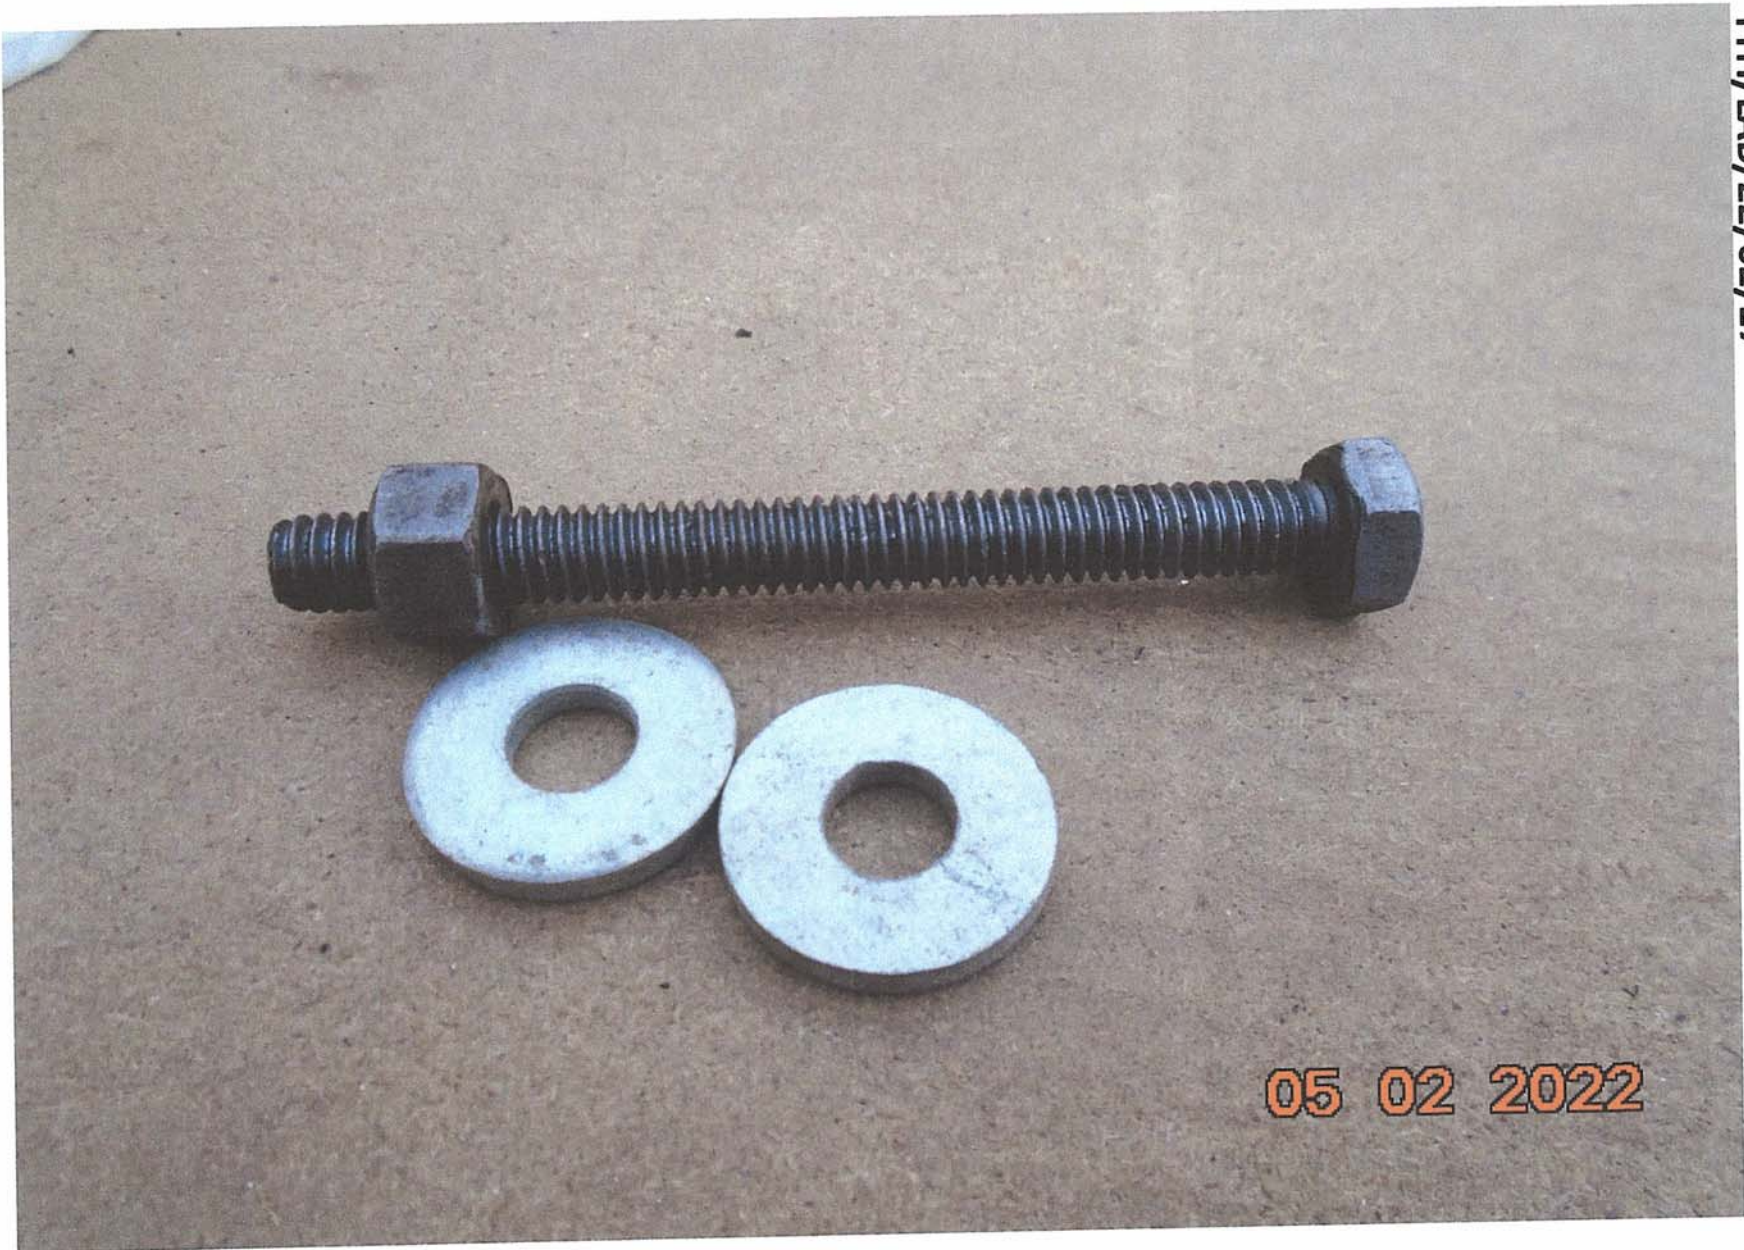
Observations : Aluminum tube frame fixed with test rig by M8 X 75 nut-bolt.

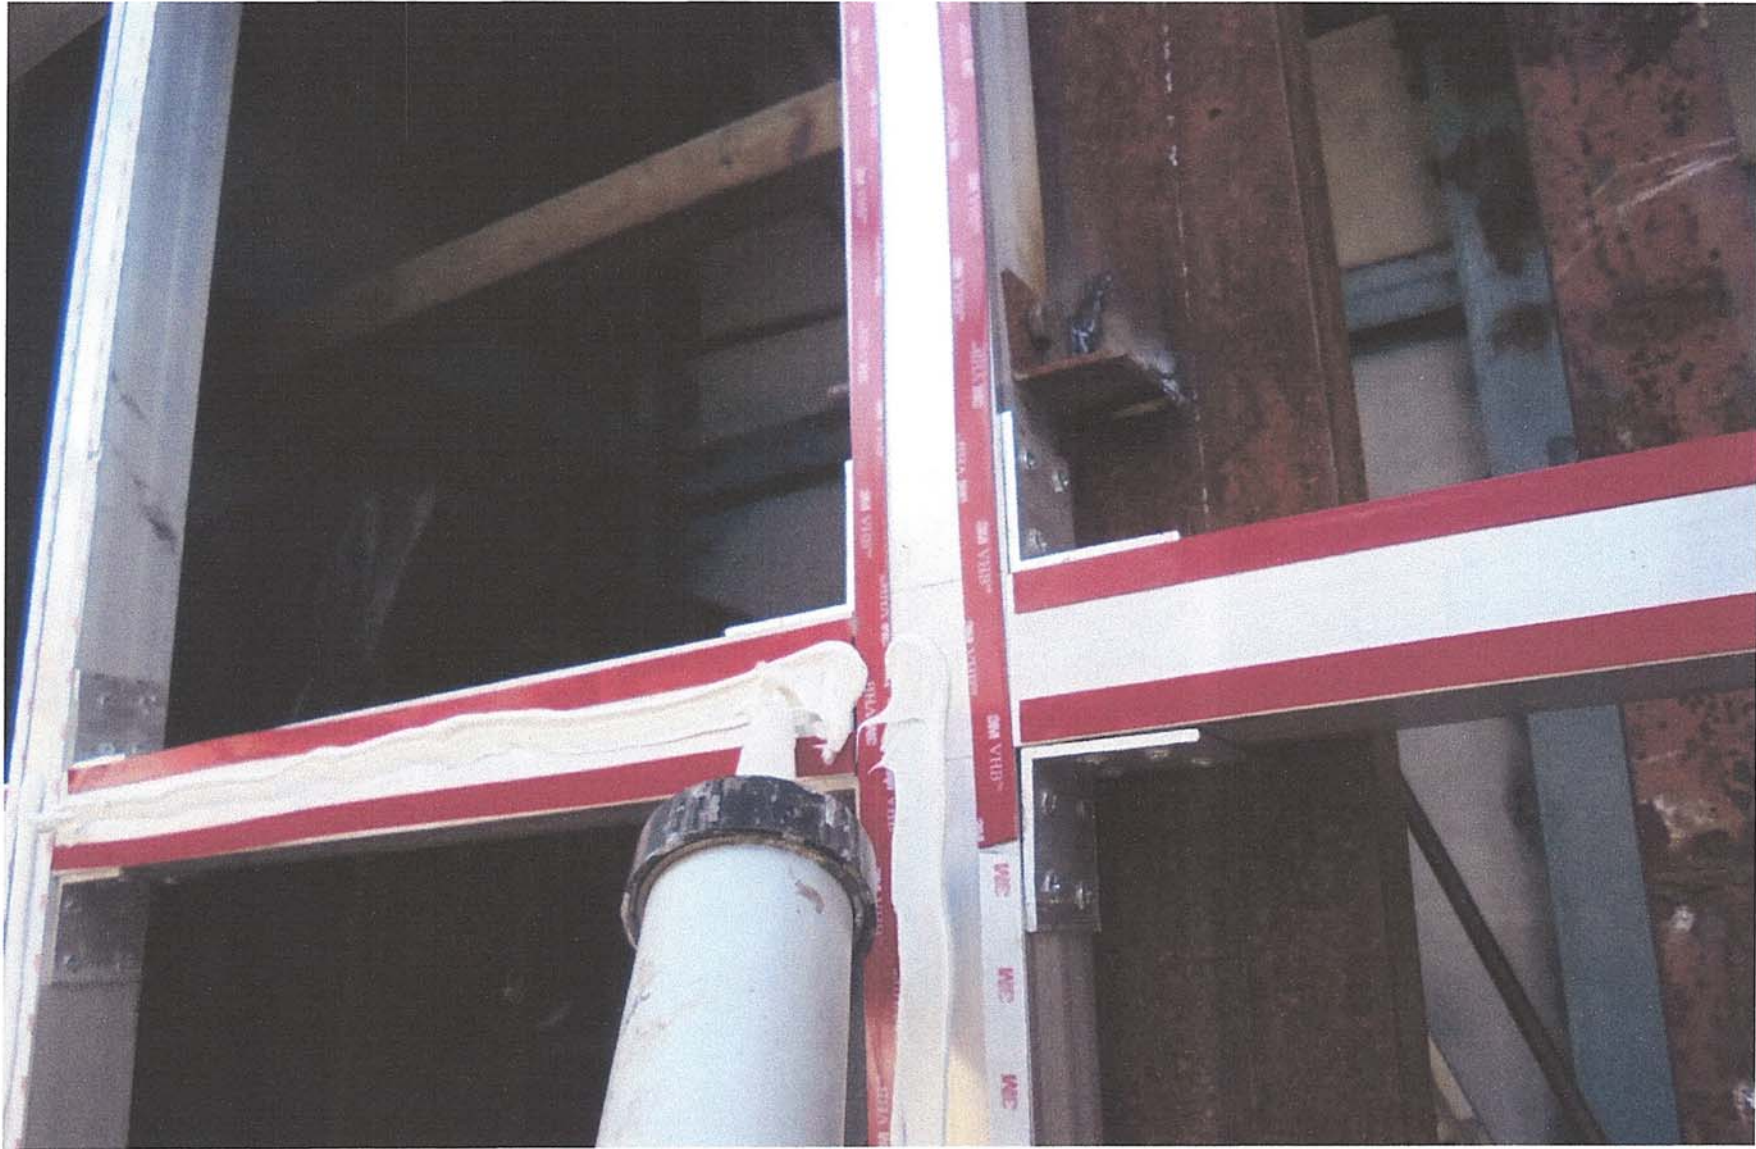
Observation: Cladding panels were fixed with main frames with help of bonding tape sealant.

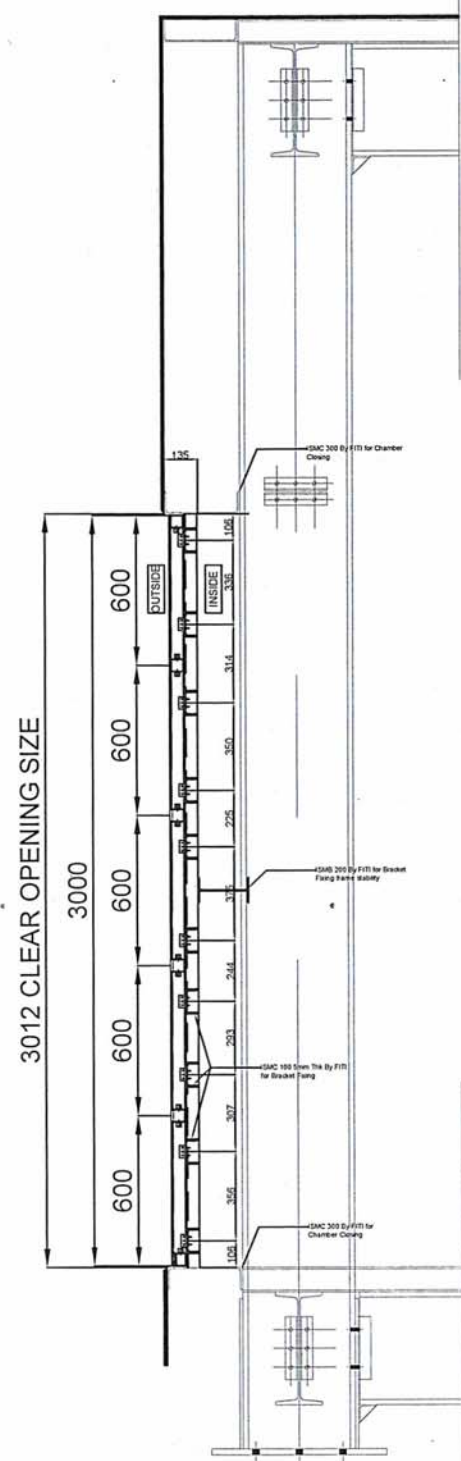
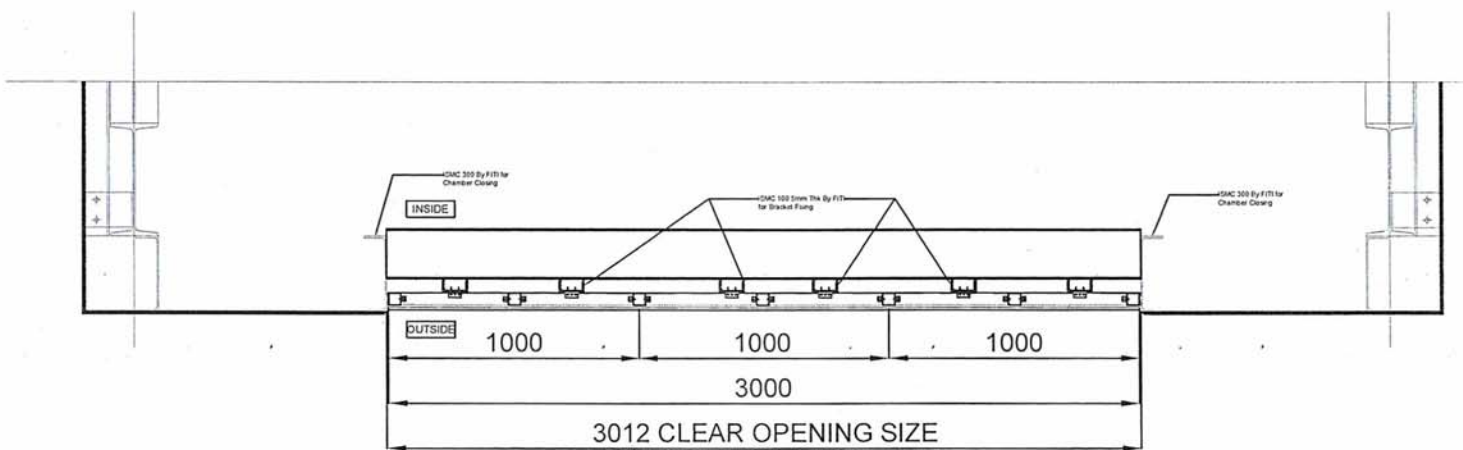
DRAWING NO :
STX/ SLAM/ DC-DT-02

ELEVATION

SECTION-A-01

PLAN-B-01

TRANSDUCERS POINTS	
LAMINAM PANEL	ALU. PROFILE
T1	T4
T2	T5
T3	T6
